Transport  
Canada

TP 185E  
Issue 3/2006

# AVIATION SAFETY LETTER

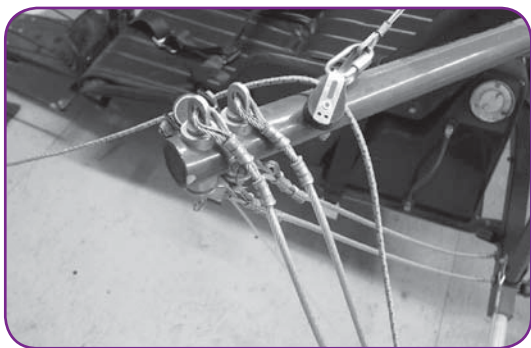
The pilot encountered control difficulties immediately after lift-off, and at that time, it was observed that a stainless steel riser cable was looped around the left outrigger arm. The pilot and passenger attempted to slide the riser cable over the end of the outrigger to remove the loop; however, the cable was taut and could not be repositioned due to the air loads on the canopy. The left turn progressed to a tight left spiral, and the parachute collapsed prior to the cart impacting the ground.

Figure 1. Close-up of left outrigger and eye bolts, with the riser cables in the correct pre-flight position

With either system, a pilot must verify that the steering lines, risers, and suspension lines are correctly positioned above the outrigger arms on the pre-flight check, by "walking the lines" with the parachute canopy and suspension lines laid out behind the cart. Standard practice also requires that the pilot apply partial power to get the cart rolling slowly at the beginning of the take-off run, and then conduct a "shoulder check" to the left and right as the parachute rises over the cart, to visually confirm that the steering lines and risers are correctly positioned above the outrigger arms. If a riser or steering line wraps around an outrigger, the wrap will effectively shorten the riser or steering line, which precludes proper chute inflation (see Figures 3 and 4).

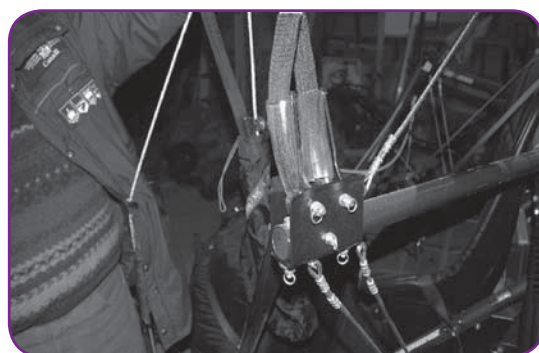
The powered parachute utilized aircraft-grade eye bolts to attach the stainless steel riser cables to the outboard ends of the outrigger arms. The nicopress thimble-eyes on the riser cables allowed the riser cables to move freely in the eye bolts. The steering lines were routed through hardware mounted inboard of the eye bolts (see Figure 1). Newer versions of the aircraft utilize a slightly more rigid system of shrouded nylon riser straps in place of eye bolts and cables (see Figure 2).

Figure 2. Close-up of newer design riser straps in the normal in-flight position
